# Leak Detection

## Commercial Case Study

Client – English Welsh Scottish Railways Plc

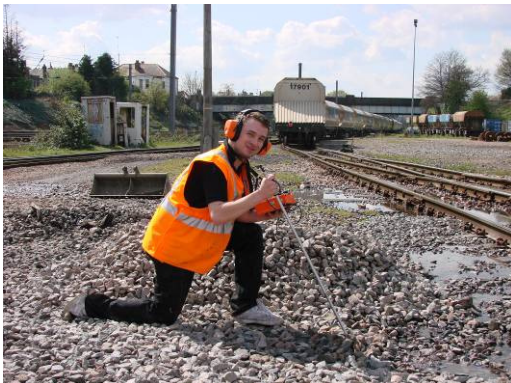
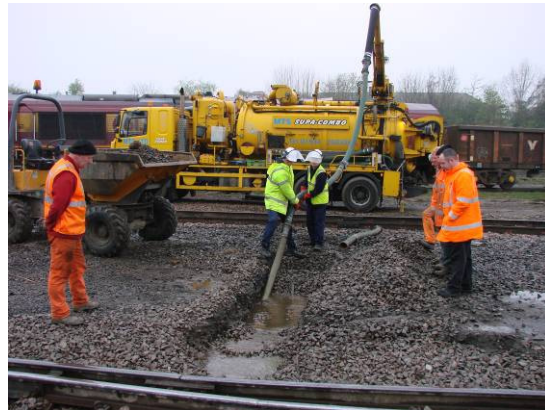
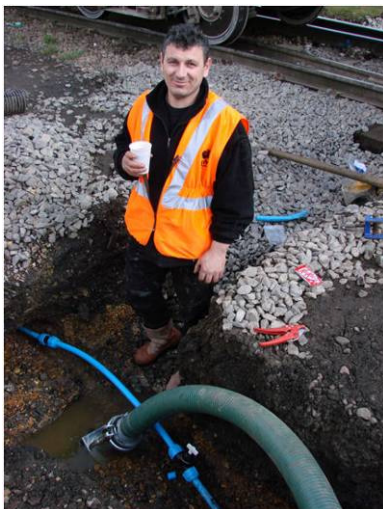
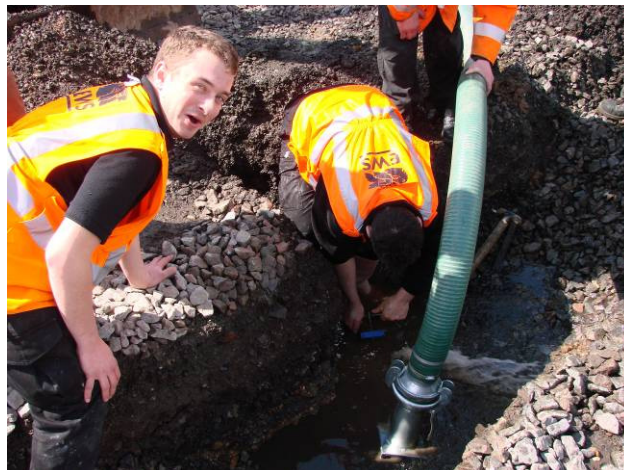
**Objective** – Our client had no water due to a leak (or leaks) on there incoming water supply to a large track depot. The mains water supply traveled approx a 1000 meters from the mains isolation valve along operating tracks to the various depots on site.

**Our Response** – We were able to attend same day, carry out a risk assessment and site survey. We correlated the mains supply and identified a potential leak within an hour of being on site. Although there were no visible signs of water leakage, we carried out chemical analysis of the water in the soil and found large amount of chlorine which indicated that 'potable water was present in large amounts. The spot was excavated and the leak was identified as a defective joint on a 32mm blue HDPE poly main, this was quickly repaired. After the repair, the pipe was purged and all connections checked.
